Jorgensen Forge Outfall Site Quality Assurance (QA) Daily Report Form

Date	9/21/2015
Name	Kristen Kerns, USACE
Time onsite	0715-1330
Weather (temp, conditions, wind)	65 degrees F, Winds N at 4mph, partly sunny
Work performed today	Backfilled trench along CMP. Pulled trench boxes and dry deconned boxes. Wet deconned excavator buckets that were in contact with Subtitle C material. Overexcavated small pocket direct north of trench an additional 3 feet to 9 feet bgs.
Problems encountered?	- Personnel smoking in exclusion zone; smoking while operating equipment
Notes	- Analytical samples taken of top of backfill; analytical results taken at bottom of overexcavation of pit north of trench.
Issues for follow-up	- 24 hour turnaround of analytical results for bottom of pit before backfill can occur. Expecting to partially demob tomorrow morning (trench boxes) then will backfill once analytical come back. -
Photographs taken?	Yes <input checked="" type="checkbox"/> No <input type="checkbox"/>

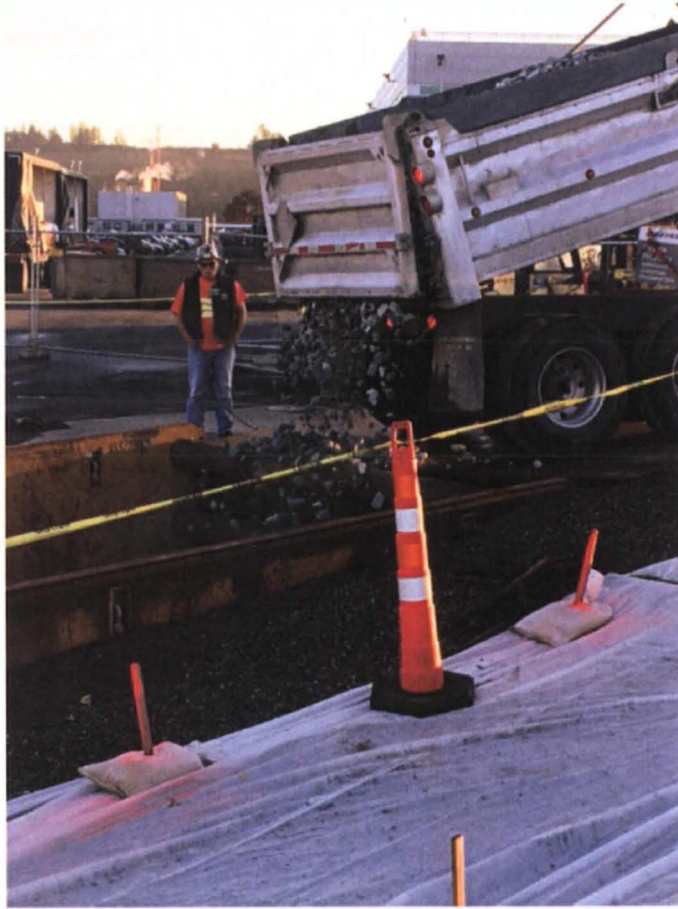
Photo 1: gravel direct unload for bottom of trench.

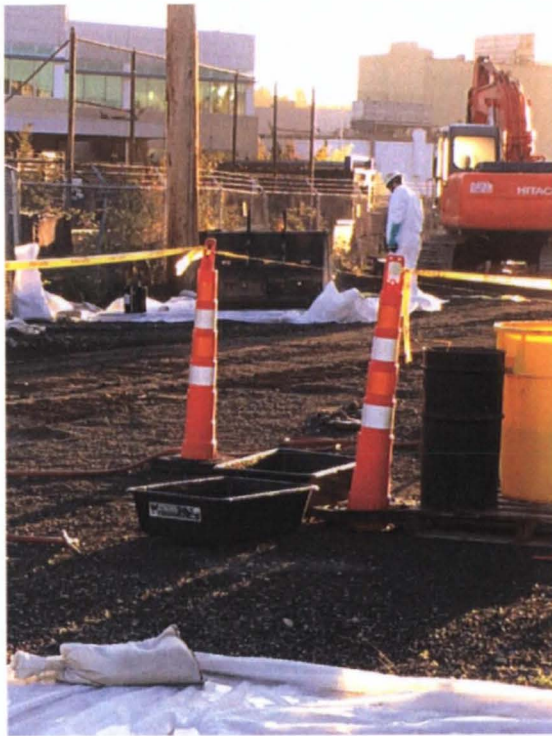
Photo 2: wet decon of excavation bucket in contact with Subtitle C material

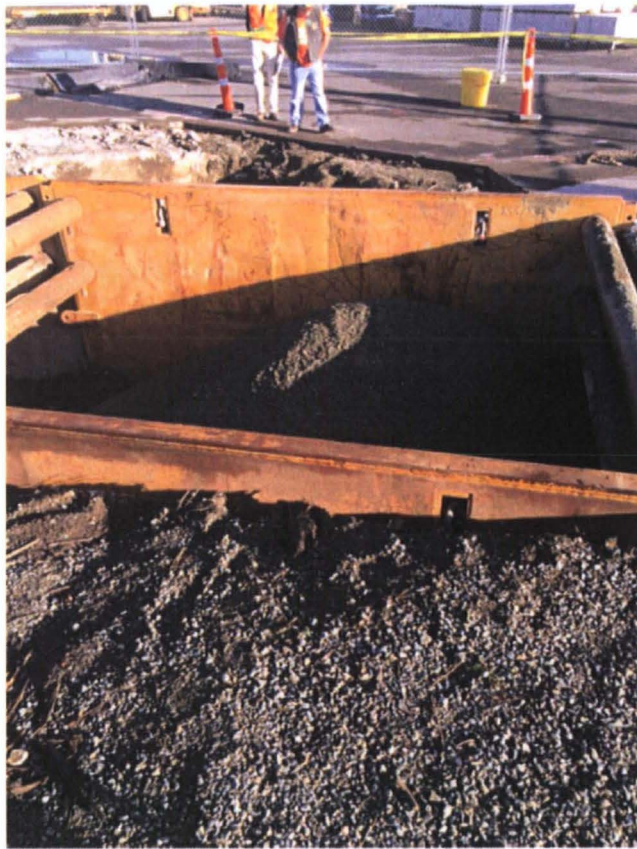
Photo 3: Direct unload of gravel borrow into trench pit.

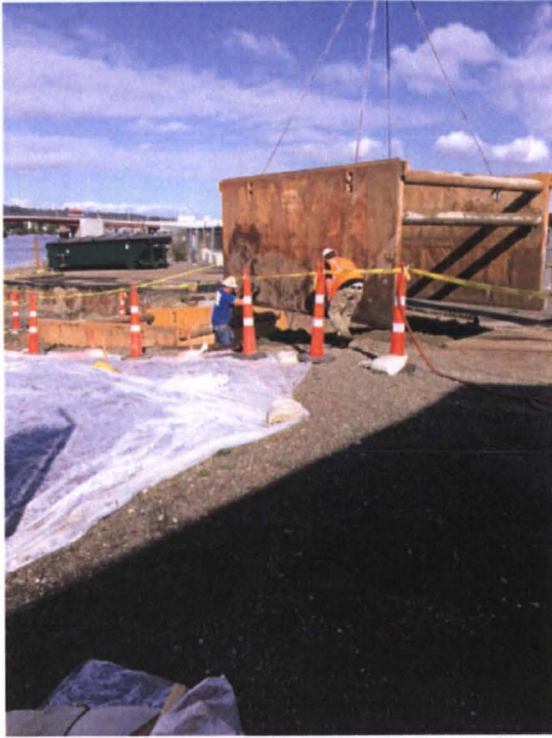
Photo 4: dry decon of trench box

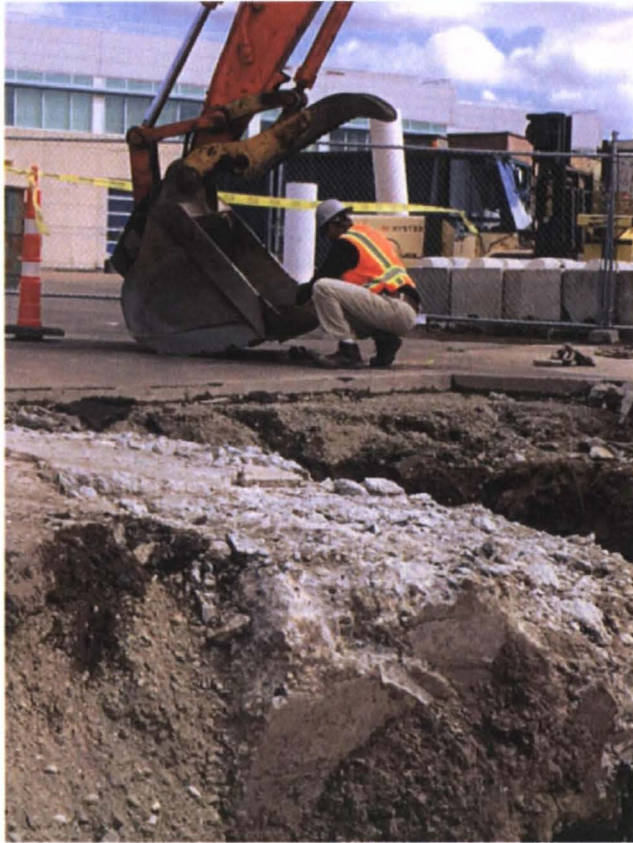
Photo 5: soil collection at bottom of pit over excavated just north of trench

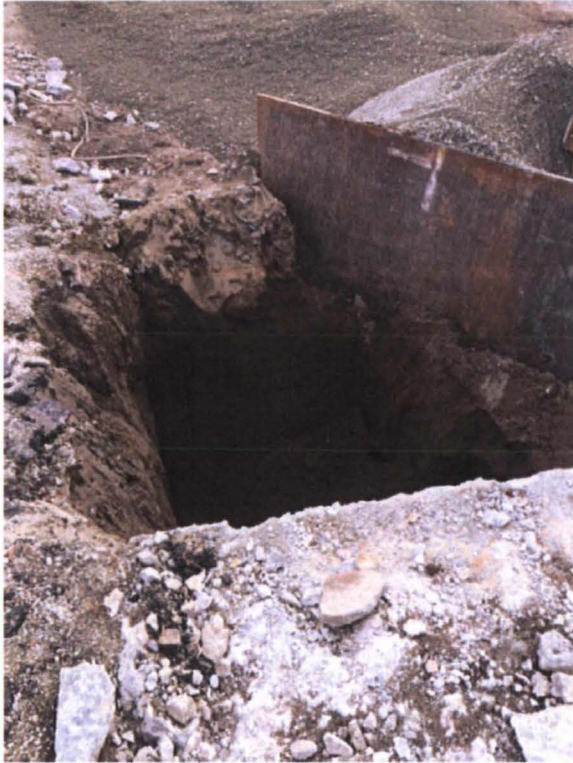
Photo 6: over excavated pit

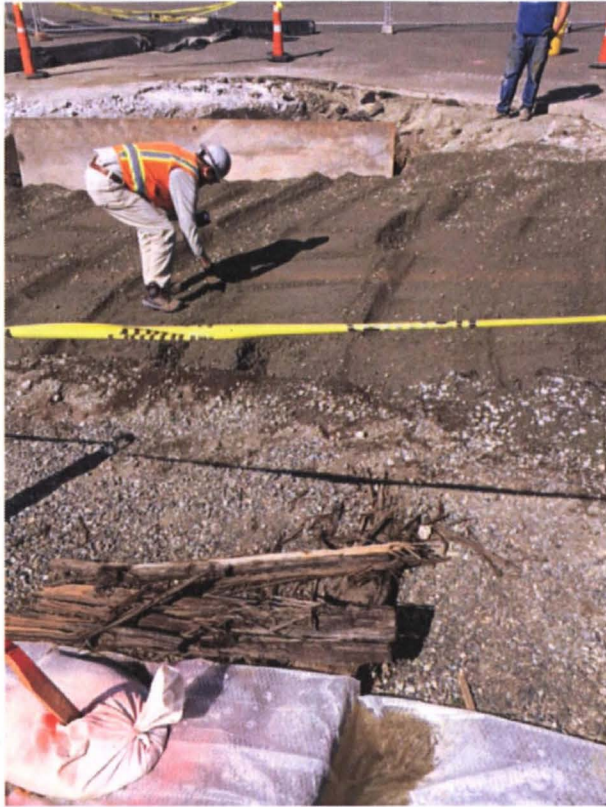
Photo 7: sampling of backfill prior to rip rap placement

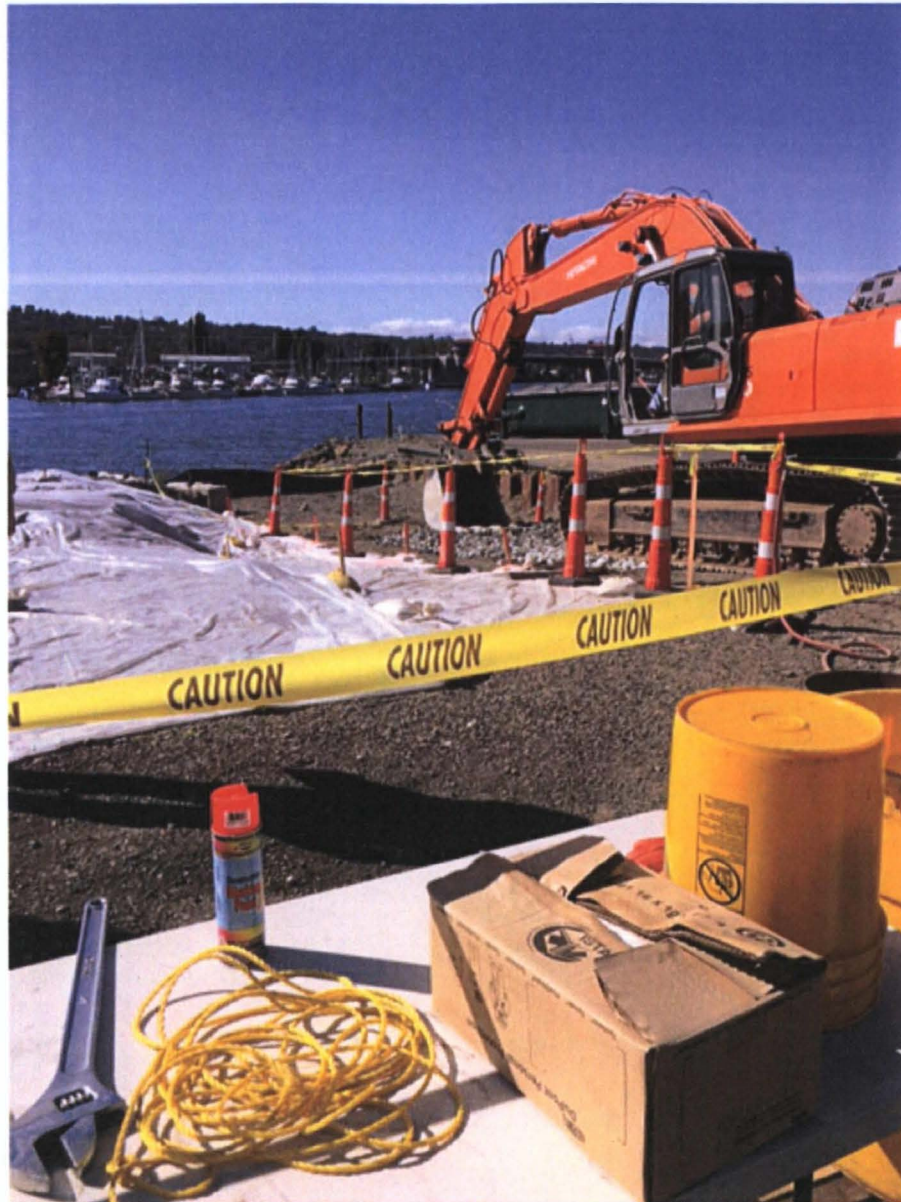
Photo 8: riprap placement
